The Medieval Church in Iermata Neagră – *Feketegyarmat* (Arad County)*

Florin Mărginean, Tamás Emődi

Abstract: The restoration works performed over several years at the Reformed church in Iermata Neagră have allowed specialists to embark upon wall-face and preventive archaeological researches. The two archaeological campaigns performed in 2008 and 2016, as well as the analysis of the masonry structure, have led to the reconstruction of the monument's relative chronology. We have focused on the identification of the planimetry and of the medieval phases of the church, as well as on the impact of the modern reconstructions.

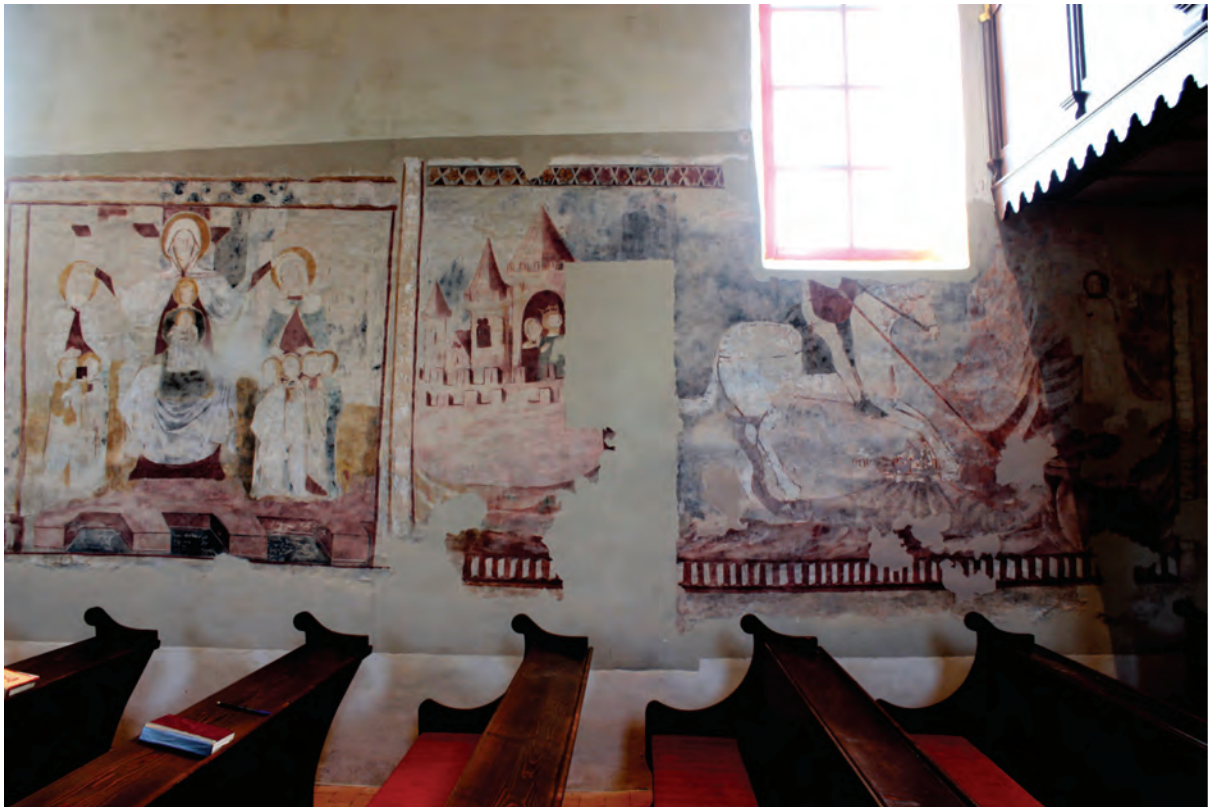
Fig. 5. Wall paintings on the southern wall (The Holy Kinship and St. George with the dragon).

The neighboring scene, that measures 4.3 × 2.3 m, set between a cartouche decorated with geometric elements, depicts the most popular scene in the legend of St. George (Fig. 5) who was killed in 303 after having publicly confessed his Christian faith. The city of Cyrene in Libya is depicted on the

left, suggested by walls and towers crowned by merlons, with the king and queen watching discouraged St. George who wears a halo, on horseback, in the center of the image, holding a shield and a spear, facing the dragon that had built a den near the spring that provided water to the city. Due to the window opened there, the upper part of the military saint's body has been destroyed; only his armored leg had been preserved. On the right side of the image the artist has depicted Cleoldine, the king's daughter, kneeling. According to the *Legenda Aurea (Sanctorum)*, the girl dragged the defeated dragon to the city with her own girdle, as the saint had encouraged her to. The body of the dragon, lying on its back, is clearly visible though fragmentarily preserved and not rendered on Kallós' copy. The analogies

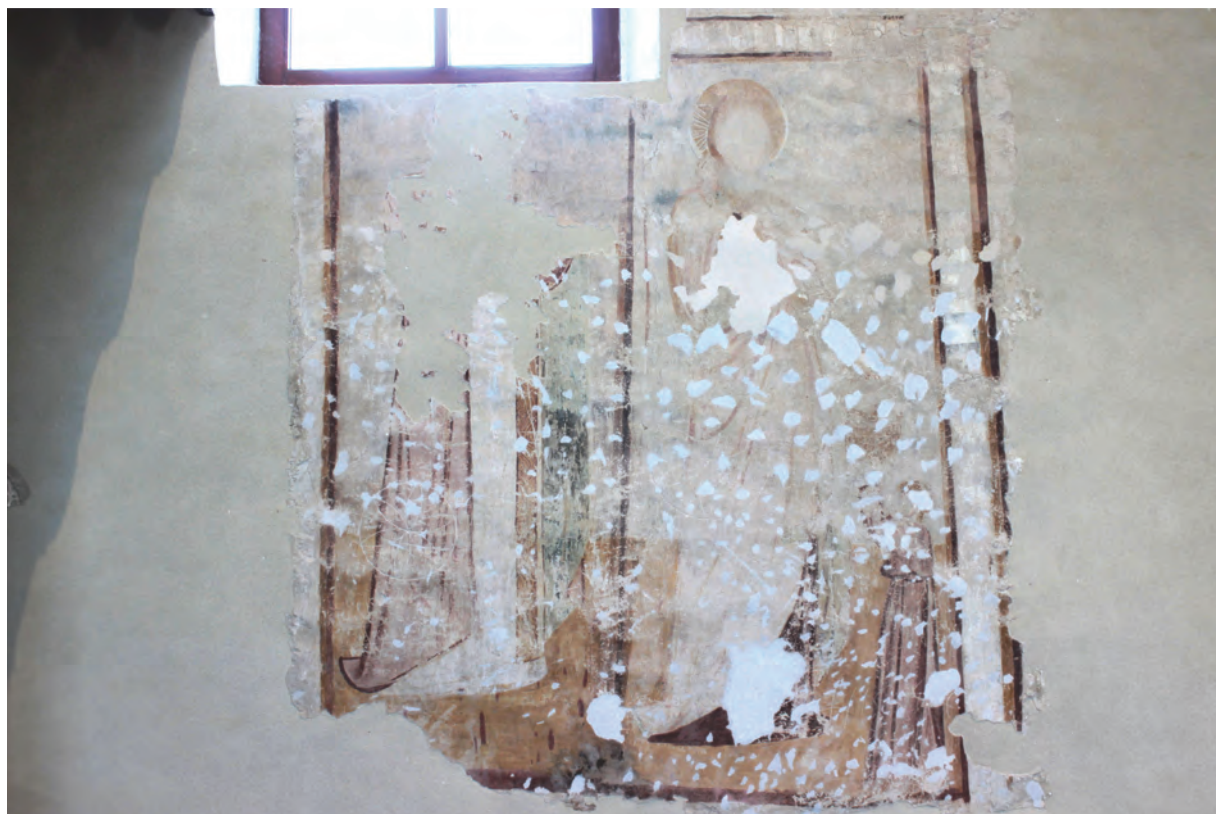
Fig. 7. Paintings depicting St. Helen and St. Dorothy on the northern wall of the nave.

The wall-face researches performed in 2015 have led to the discovery of wall painting fragments on the northern wall of the nave (Fig. 6). The 4.9 m segment from the middle of the medieval masonry depicts four narrower scenes with frames and a wider scene. The first from the west, slightly cut by the modern window there, depicts St. Hellen holding a cross (Fig. 7). The main character of the second scene has been poorly preserved, but according to the gesture of the child on the right side, raising a basket, one can identify St. Dorothea based on the details of her legend in the Golden Legend. Dorothea had chosen to sacrifice herself for Christ, receiving a sentence of decapitation from the governor of Caesarea, Saprichie, but a beautiful youth appeared on the spot of the execution and handed the maiden three apples and three red flowers from the Garden of Eden. Dorothea is usually depicted in medieval wall painting and sculpture only with the basket in her arms, but one also knows scenes similar to the one described above in St. Jacob's church in Levoča (ca. 1420) or the church in Mecseknádasd (dated to the beginning of the 15th century), Mălâncrav (cca. 1400), Mugeni or Chilieni²¹.

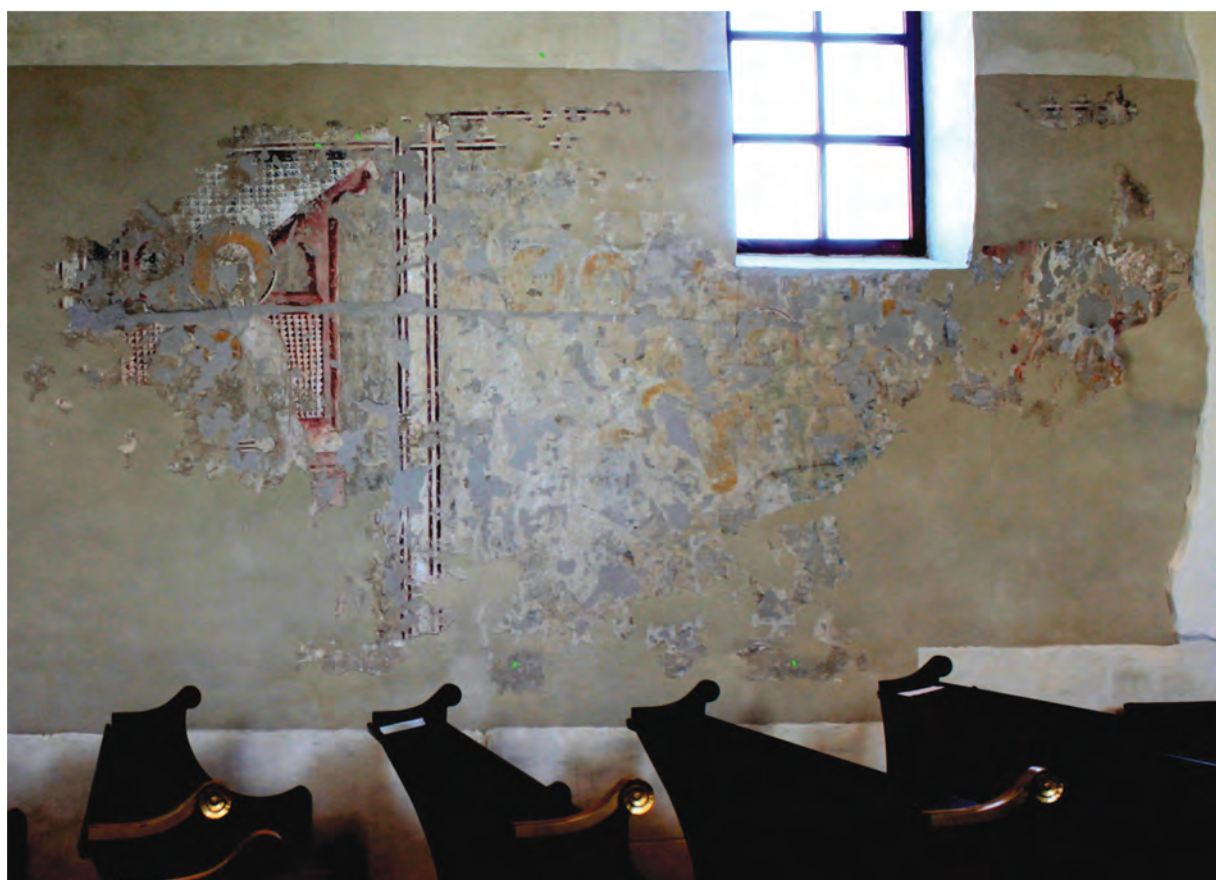
Fig. 8. The Mother of God enthroned with Christ child and the Adoration of the Magi.

The third scene has been destroyed beyond recovery, while the two others to the east share the same frame, decorated with stripes painted red, white, and burgundy. Only the upper half of the fourth scene has been preserved, depicting the Virgin on a throne, wearing a white mantle decorated with red lozenge-shaped motifs, holding Christ Child in her arms, who raises his left hand that probably holds an orb surmounted by a cross. The final scene depicts the Adoration of the Magi, with two crowned kings, with halos, on the left side of the image, standing, and one kneeling in front of Mary with Christ Child. The fine features of their faces, though rendered in faded colors due to the degradation of the painting layer, reveal the special quality of the work. One also notes another figure above Mary's head, probably an angel with a halo holding a book, and yet another, unidentified character behind her (Fig. 8).

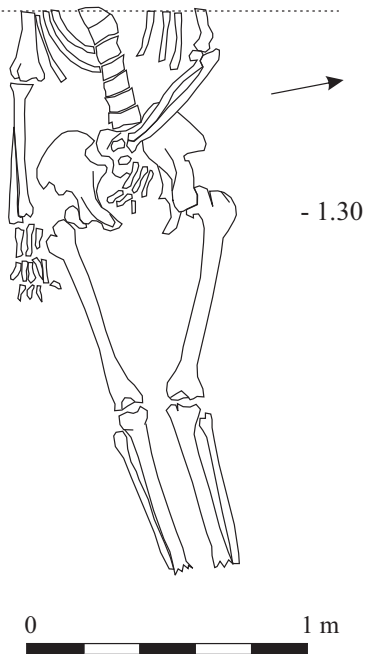
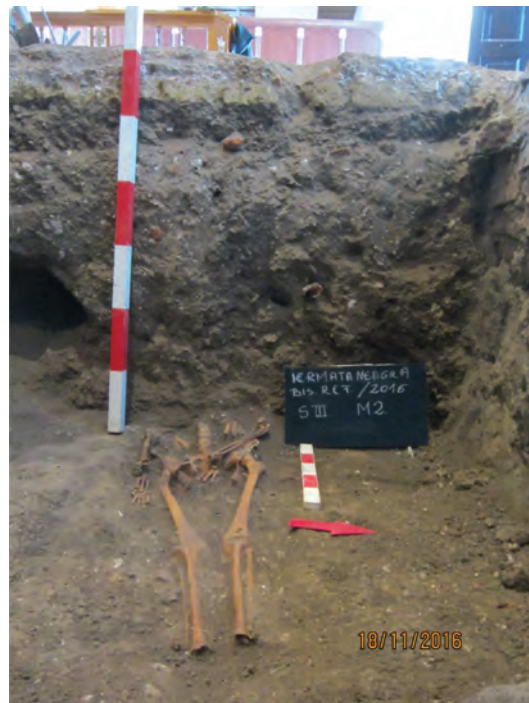
Plate 6. Trial trench S 03, western profile, grave M 05 and image.

1. Fill with sand, mortar; 2. Fill with mortar, rocks; 3. Ground level, clay; 4. Level pigmented with mortar, roof tiles, bricks; 5. Clay; 6. Fill, black layer, sired, pigmented with mortar; 7. Construction level; 8. Filling layer, compact, black; 9. Sandy, black, aired layer, pigment with mortar, roof tiles, bones; 10. Sandy layer, very aired, black, with bones, pigmented; 11. Black, compact layer, similar to the layer near the sanctuary of the Romanesque church, northern side; 12. Black aired layer, spot of M 05, M 02; 13. Sandy layer with bone fragments; 14. Construction level, pit 1; 15. Archaeological sterile; 16. Gothic church foundation; 17. Foundation shoulder 18. Foundation shoulder.

M05 – M06. Two overlapping graves were cut by the western side of section S03, on the inner part, near the foundation of the polygonal choir, at the depth of –1.20 m. The skeletons in these graves had been deposited in dorsal decubitus, oriented west-east. The individual in M05 had the left arm extended along the body (Pl. 6). Ribs, vertebrae, the coxal-femoral bones, and the bones of the lower limbs extremities have been preserved. The soil in the fill of this pit was mixed with brick fragments and mortar. Towards the foundation of the church, starting from ca. – 0.96 m, we have discovered several skull caps and an entire skull, as well as scattered human bones that most likely belonged to disturbed graves. The shape of the sepulchral pits of the two graves could not be identified and no items of funerary inventory have been discovered in these features.
