# The Round Church of Battonya

**Imre Szatmári**

**Abstract:** It is possible that more than two hundred medieval churches existed on the current territory of Békés county, with over 90% of these village churches. Nevertheless, only thirty-five were the object of archaeological excavations, which revealed complete church layouts or made possible at least their partial reconstruction. The plans of thirty-three of the thirty-five parish churches are known, with only two that had remained unpublished.

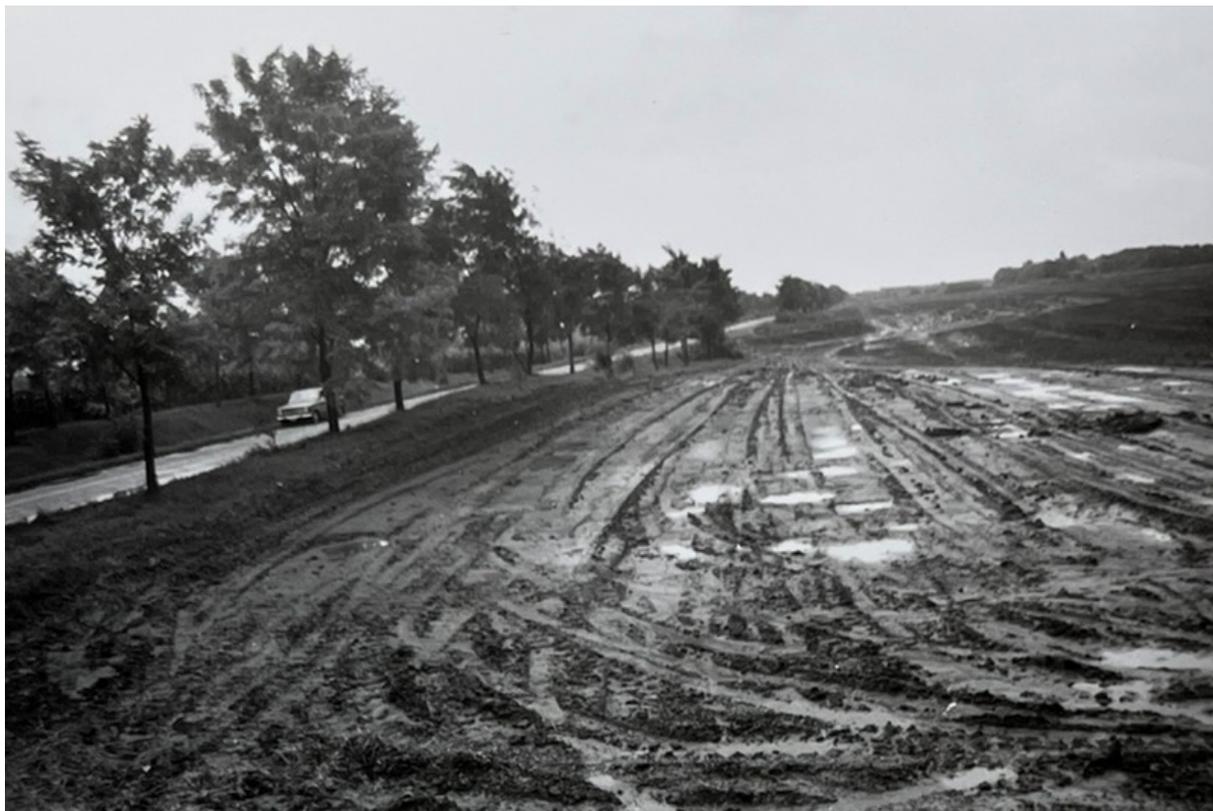
Fig. 1. The archaeological site, possibly from south-east, according to the car parked on the location of the former church. Image from the excavations, 1979.

The excavation diary and report found in the archives were dated by the excavator in charge with the archaeological investigations to the 30th of March 1980, respectively six months after the proper excavations. This could be the reason why it is impossible to ascertain all details of the documentation, not even based on drawings and photos. The accurate location of the excavations is also uncertain, as no site plan and no basic plan of the excavations had been drafted. There are no drawings to show the location and limits of the excavated area and its extensions mentioned in the excavation diary. There are no cross-section drawings, not even of the midway baulk. The location of the two graves is unknown and there are no grave drawings. Two of the photos are of the round church, one of the human bones discovered within the site’s surface, one shows the church’s location and two indicate earthwork traces performed on the site. The two photos of the rotunda are almost identical in terms of composition, one is unclear, while the accompanying descriptions are partially illegible and therefore, disputable. Of the six photos, only three could be of use: one is of the earthworks carried out on the site, the other shows the excavation site and the third is of the round church excavated to the lowest brick level. In the latter, a two-meter length measuring equipment, barely visible, likely not entirely stretched and set horizontally central to the round church, indicates building sizes (Figs. 1-3).

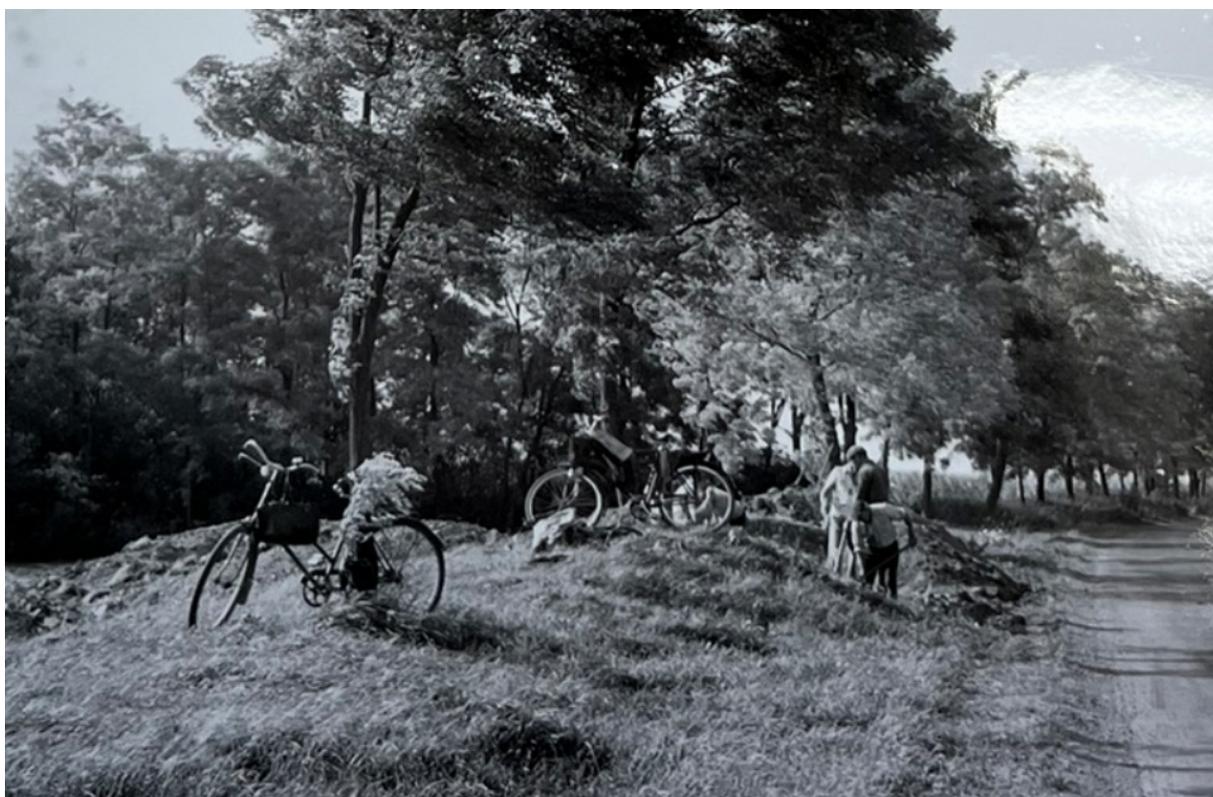
Fig. 2. Location of the church find from south-east. Image from the excavations, 1979.

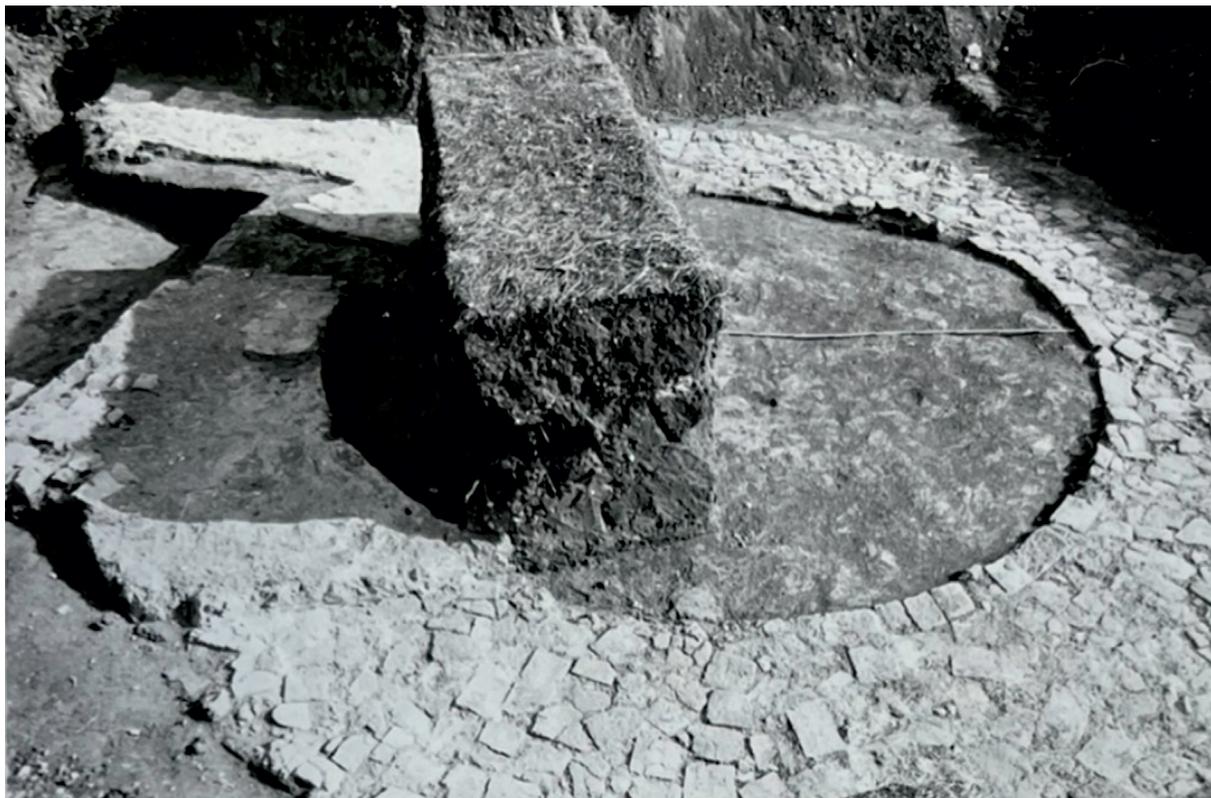
Fig. 3. Base wall of the rotunda from north-west. Image from the excavations, 1979.

The destruction level of church foundations measured from the surface is unknown, however, on the basis of the support wall visible in the photo, it was approximately 80 cm from topsoil, gradually descending eastwards. In the photo, the farmed upper layer and a thicker layer beneath may be clearly distinguished by the junction of the north-western end of the support wall. By the corner of the support wall foundation, there is likely a less mixed excavation, coarse, possibly the ditch of the foundation pit. The lower layer, on the other hand, seems homogenous inside the round church. The excavation documentation does not contain data on artefacts discovered in the archaeologically important approximately 30 cm thick layer, which lay between the two-three approximately 20 cm surviving levels of the foundation (brick-clay-brick), and the 30 cm deep farming layer. The accuracy of the statement on the possibly surviving floor level is disputable for two reasons. On one hand, according to details that may be inferred from depth data, a level difference of only approximately 60 cm between the lower part of the foundation and the floor level is unlikely to have existed. On the other hand, the “*thin, white lens, only one or two centimetres wide*” mentioned in the excavation diary as floor level had emerged by the base of the farming layer, so that not only its origin, but also extension are uncertain. The thin mortar layer might have been resulted from the foundation phase, when the mortar-set bricks began to be placed on top of the first one-two brick layers and clay.

Nevertheless, the photo clearly shows that during construction, the larger and more intact brick pieces were selected and placed on the sides along the internal limit of the foundation trench, set longitudinally along the arch. There are no intact bricks in-between these. According to the photo, the same method was not utilized on the external edge of the foundation, since intact bricks might have been entirely used. Midway the wall, there are only smaller brick pieces, set randomly, yet always horizontally. There are no data on brick sizes and these cannot be deduced from the 1:20 scale plan.

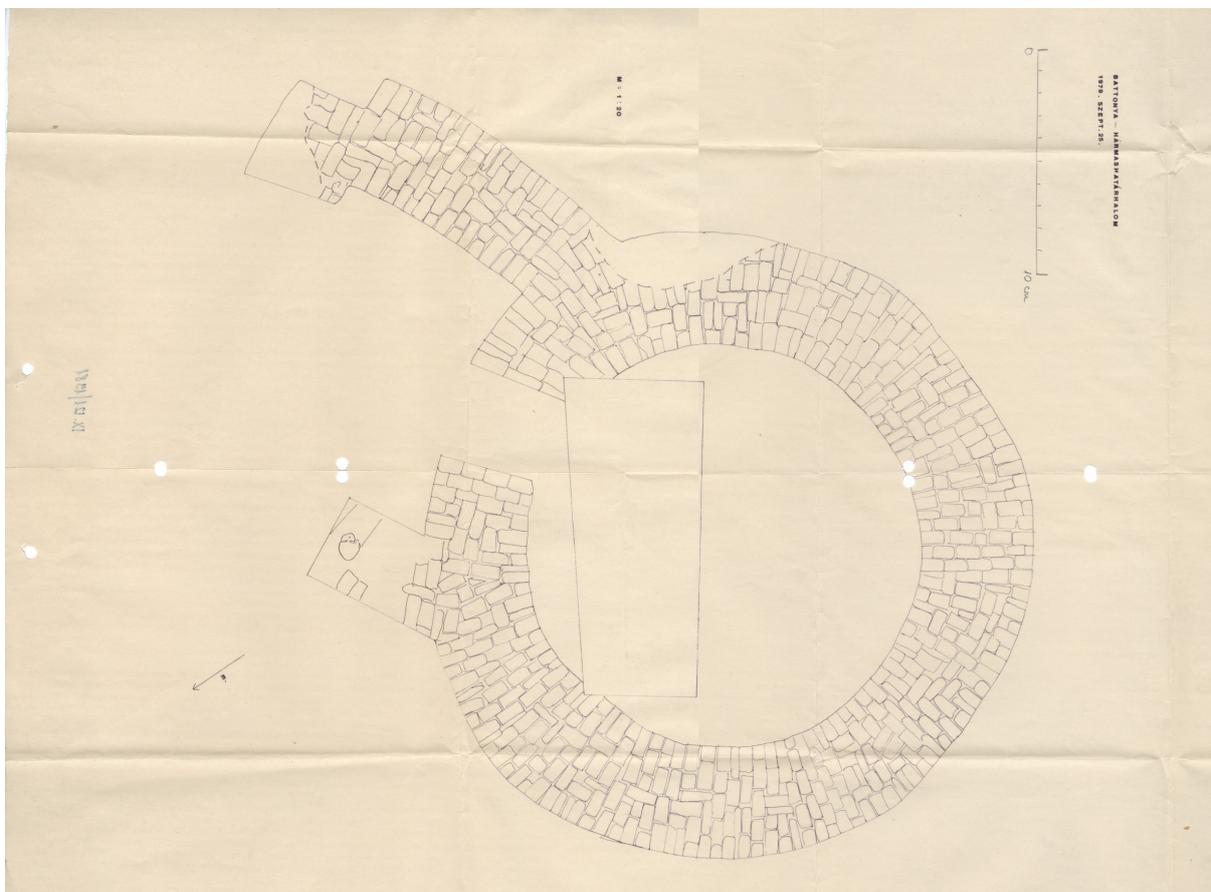
Fig. 4. Sketch of the rotunda according to the excavations, 1979<sup>4</sup>.

Based on the results of the synthesised two excavation documentations – assuming that the 1979-plan accurately records the location and size of the foundation walls – data on the round church may be reconstructed as follows.

The building is oriented south-west and north-east, the sanctuary deviating approximately by 25° northwards from east. The external diameter of the nave is of 5.3-5.6 meters, the internal diameter is of 3.4-3.5 meters, while the foundation wall width generally varies between 90 and 100 cm, reaching 110 cm in only one or two places. By the access into the sanctuary, the nave foundation is discontinued on a 74-88 cm span and is missing. The limits are slightly at an angle and apparently are not parallel to the church axis.

According to the excavation plan, the bricks’ arrangement into the foundation clearly indicates that the nave and sanctuary were built concurrently, however the bricks shown on the plan do not correspond to the position of the bricks visible in the excavation photo. Nevertheless, the consistent layer of yellow clay noted on top of the bricks and systematically removed during the excavations likely confirm that the nave and sanctuary had been built at the same time. The sanctuary foundation wall is identical with that of the nave, the lower layer being also composed of brick fragments and has no level differences.

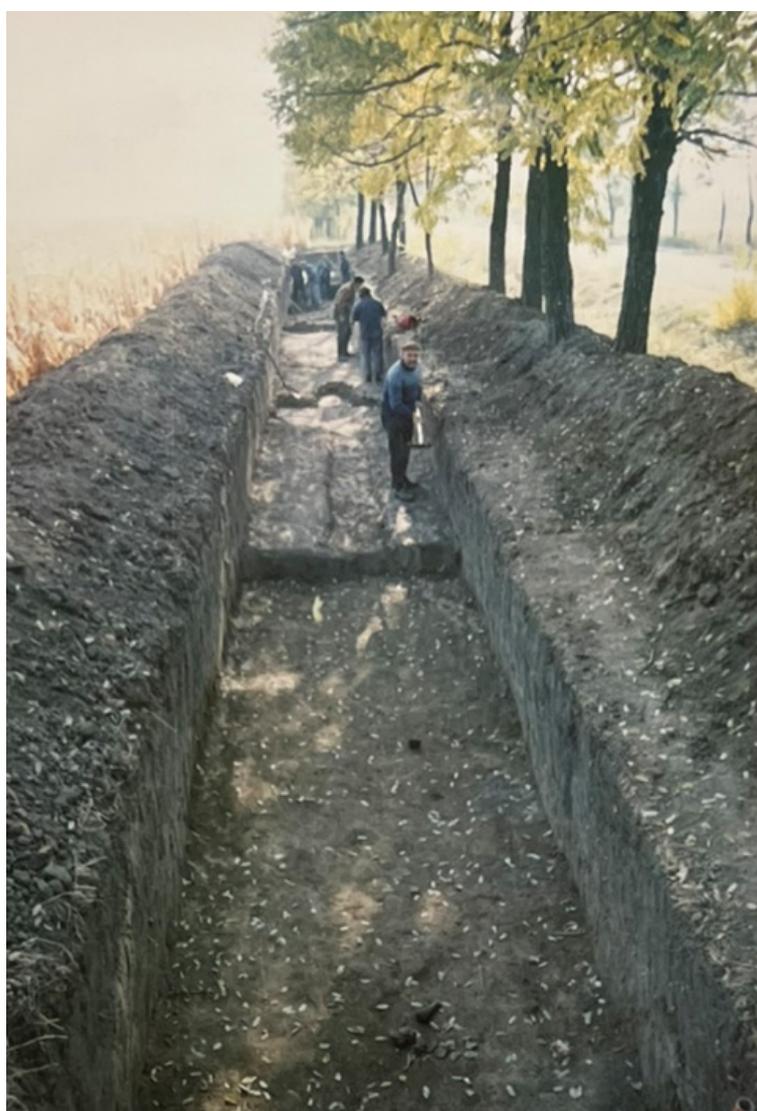
Fig. 5. Trench excavated on the eastern side of the road from north-west. Image from the excavations, 1986.

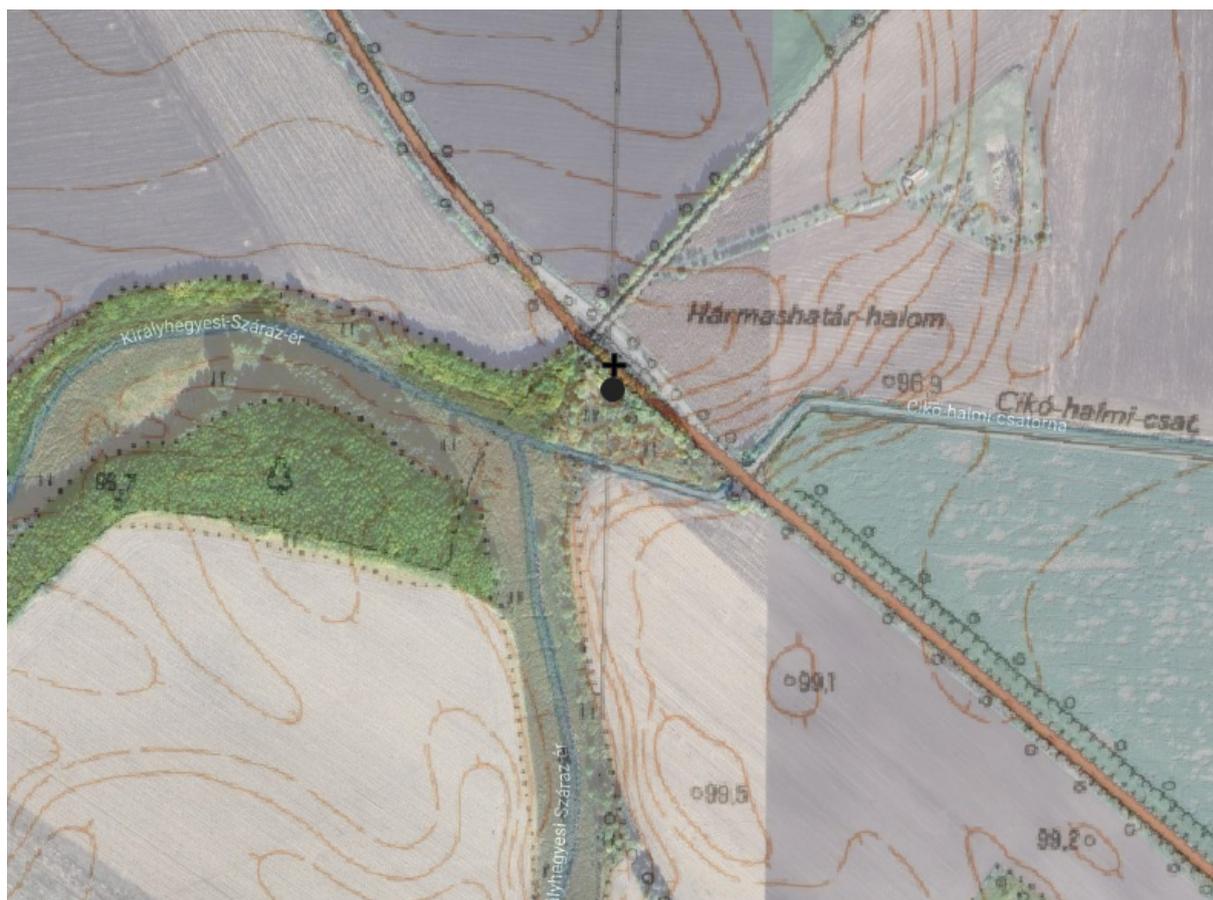
Fig. 15. Church location along the former and current routes of the road between Battonya and Mezőkovácsháza (drafted: György Kerekes, 2025).

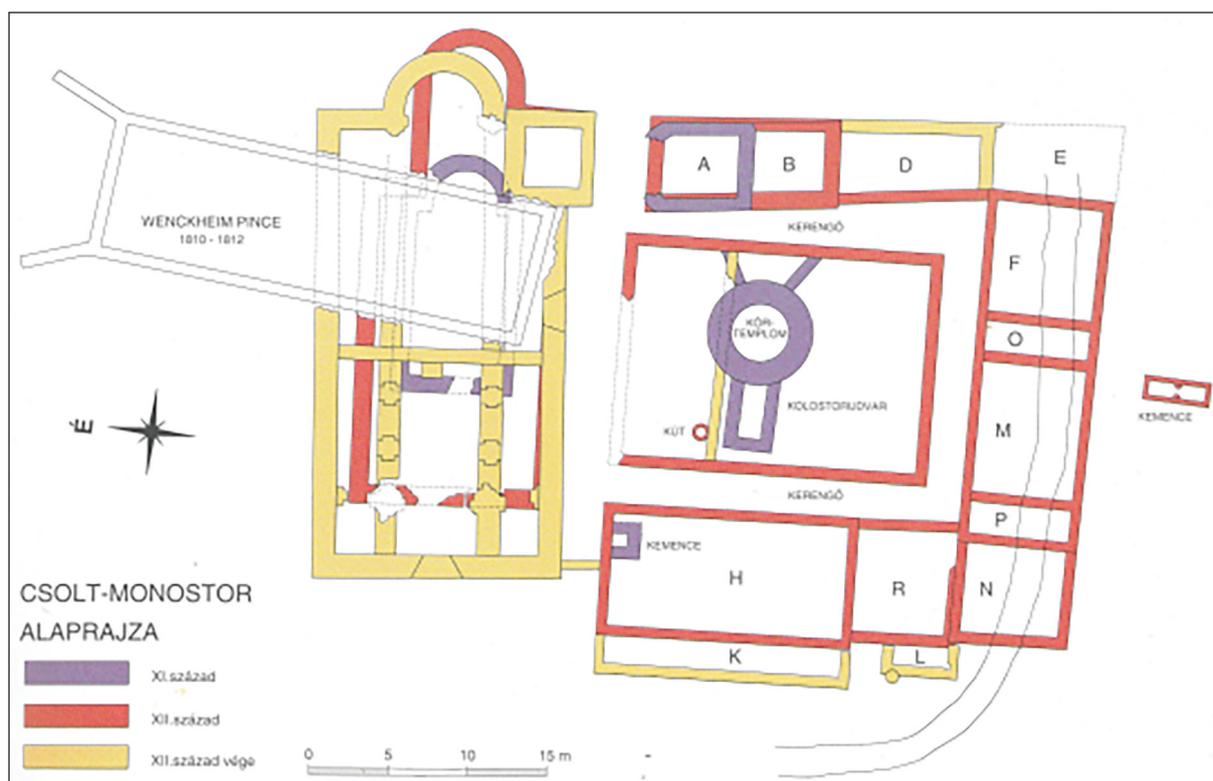
Fig. 19. Csoltmonostor monastery with a round church discovered in the monastery yard (source: Juhász 2000, 287).

monastery area and another between Békéscsaba and Gyula, on the location of the destroyed village of Fövényes. The first was identified in the courtyard of a later monastery, so that its original function is uncertain. Moreover, its plan is rather unique and uncommon in many aspects, raising a lot of questions in the light of circular churches discovered insofar. According to Irén Juhász's observations, "only the compacted clay foundation survived and one to three brick layers, covered with grey lime mortar". The external diameter of the circular part is of 6.6 meters, the internal diameter is of 3.8 meters, "together with the vestibule, its length being 10.7 meters, while the thickness of the walls was of 1.6 meters", its orientation being precisely west-east. The archaeologist dated the church to the 11th century<sup>24</sup>. (Figs. 19–20.)

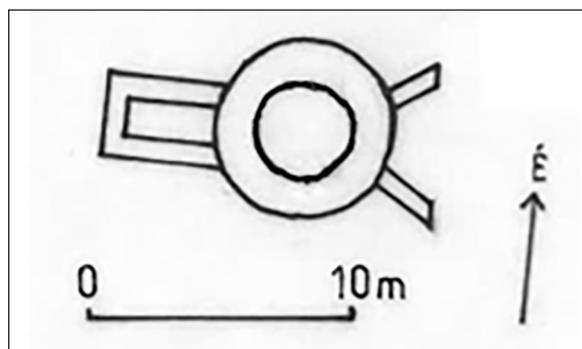
Fig. 20. Round church of Vésztő. (according to: Juhász 2000, 287<sup>26</sup>).

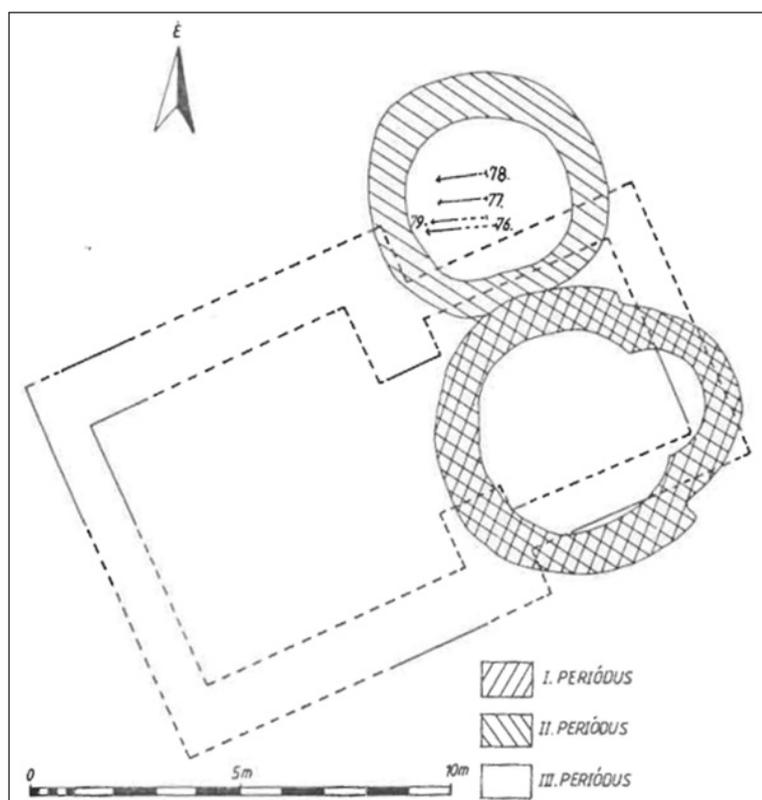
Fig. 21. Medieval church of Fövenyes  
(source: Horváth, Szatmári 1989, 380, Fig. 1).

The first church in the Fövényes medieval village was also a rotunda, slightly projecting on the eastern side, with an internal and external semicircular sanctuary. Its external length was of 7.5 meters, the external diameter of its circular section being of 6.9 meters, while the internal diameter was of 4.8 meters. The average thickness of the walls was of 105 cm. The building was oriented north-eastwards, with its axis deviating by approximately 20° from the east to the north of the sanctuary. Its foundation was composed entirely of compacted clay layers, while the walls were in brick. It was likely built in the 11th century<sup>25</sup>. Later, another round building was built adjacent to its northern side. (Figs. 21–22.)

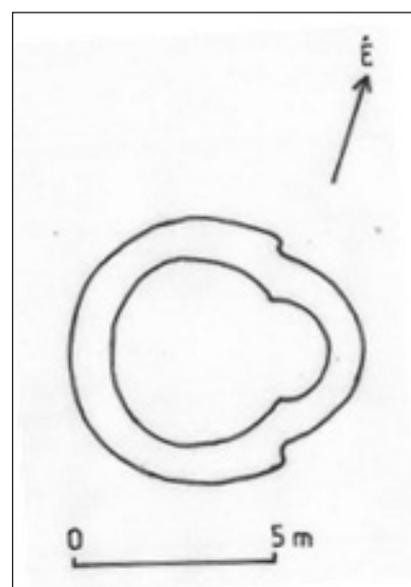
Fig. 22. Rotunda of Fövenyes  
(source: Szatmári 2004. 199. Photo 4. 11. b; conform Szatmári 2005. 176. Photo 11. 1).

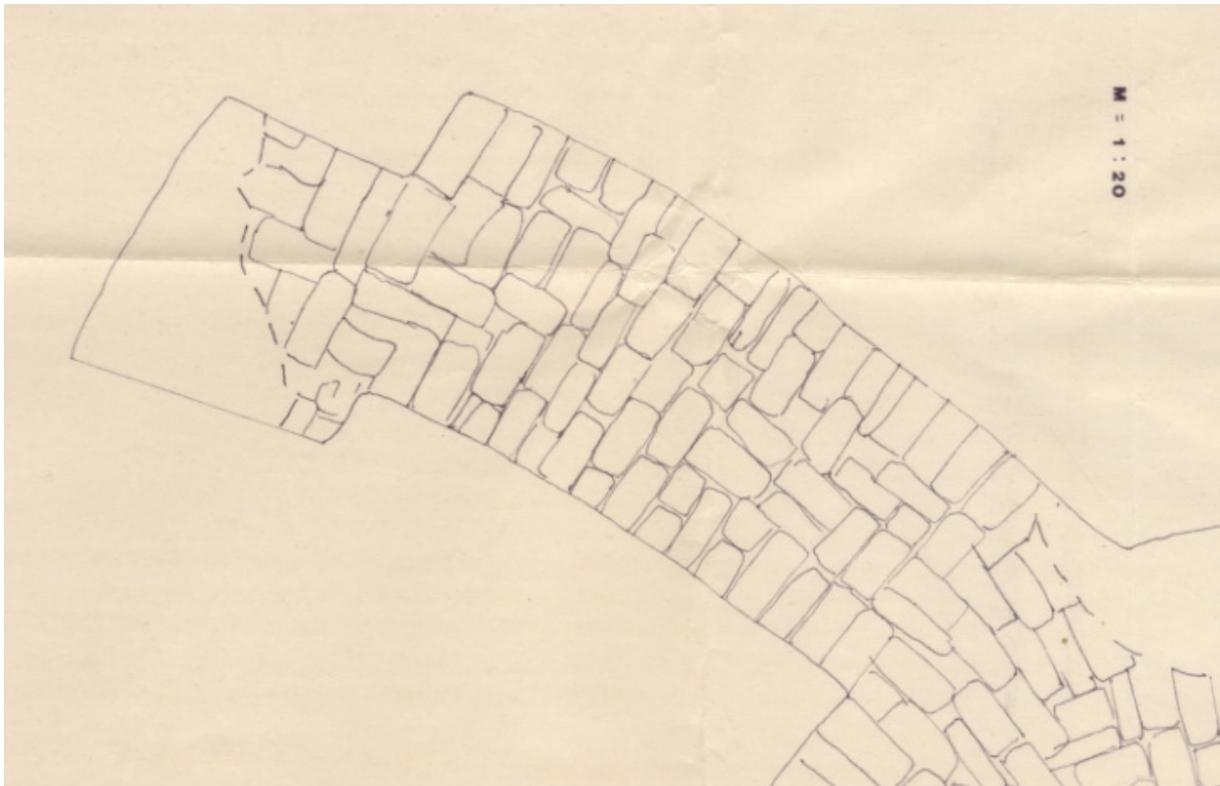
Fig. 23. Foundation of the sanctuary's southern wall according to the excavation plan.

The possible shape of the sanctuary is worth special attention. Only the beginning of the northern wall had survived, so its shape may be inferred only from the southern wall line. Accordingly, it is almost certain that the northern and southern longitudinal walls of the sanctuary slightly curved inwards, towards the centre. The reconstruction of the eastern closure wall shape is uncertain, given the few surviving details, yet there are possible two – or even three – forms. The two main versions depend of how we interpret the small angles visible on the excavation plan by the external and internal edges of the eastern end of the south sanctuary wall. (Fig. 23.)

If these evidence false real corners, then the eastern closure wall of the sanctuary was connected to the two longitudinal walls by a small corner in the exterior and interior, and of one takes the curved line of the longitudinal walls and the nave circular wall as base, then the eastern closure wall was not perfectly straight, but slightly curved. (Figures 24–25). However, it is also possible that the sanctuary had had an entirely straight closure. (Figures 26–27). If, on the other hand, the south-eastern end corners of the sanctuary were not part of the structural project of the circular church, but only the remains of the sanctuary's destruction and damage, then the eastern arch of the sanctuary may be reconstructed as a continuation of its southern wall also based on the sanctuary's northern wall remains. It might have been precisely semicircular (Figs. 28–29) or slightly concave (Figs. 30–31)<sup>31</sup>.

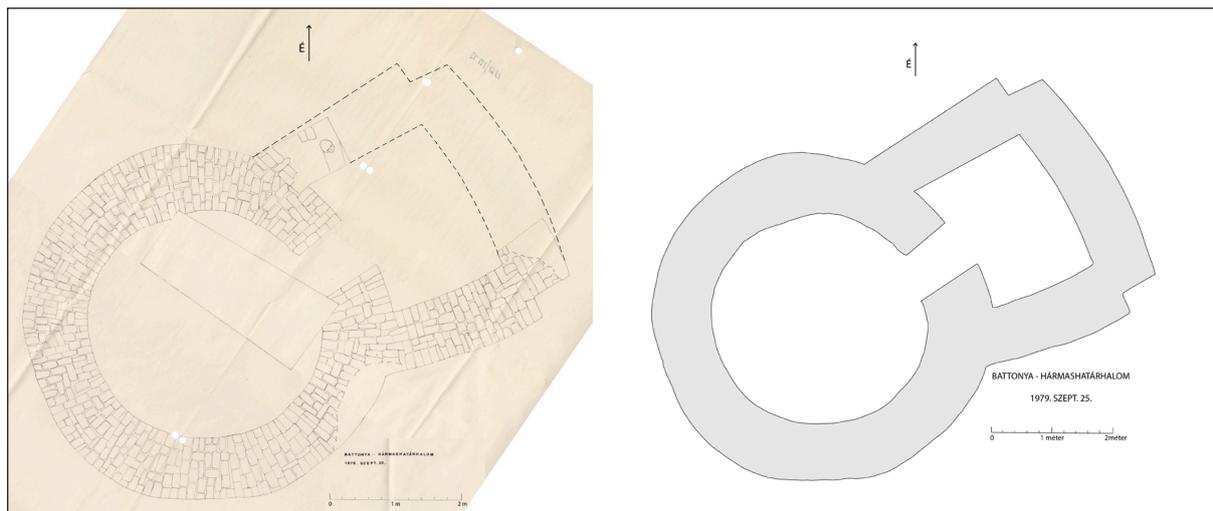
Fig. 24–25. A possible form of the Battonya round church sanctuary is angular, with a slightly arched closure (drawing: György Kerekes, 2025).

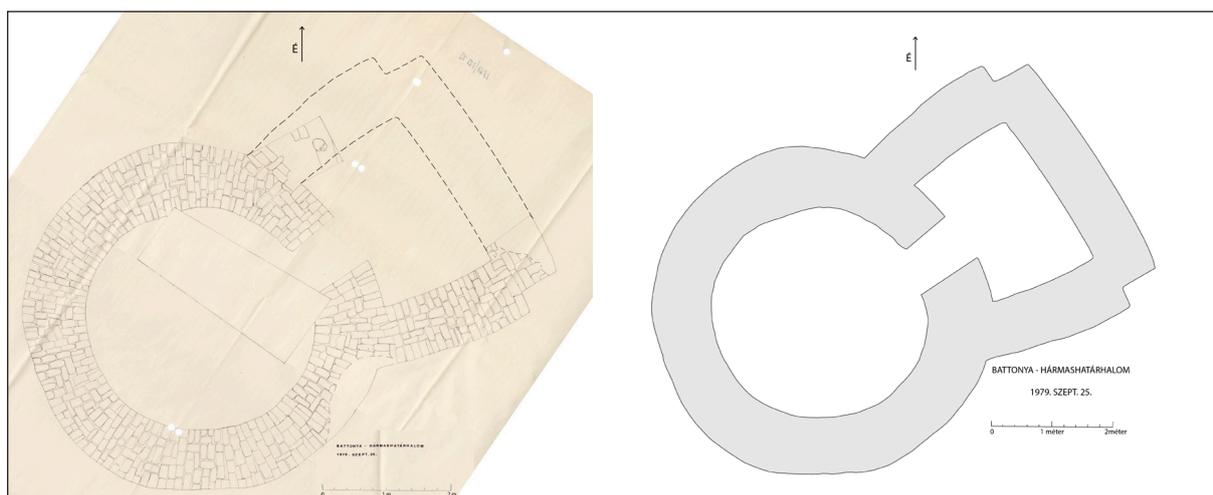
Fig. 26–27. Another possible shape of the Battonya round church sanctuary is angular, with a straight closure (drawing: György Kerekes, 2025).

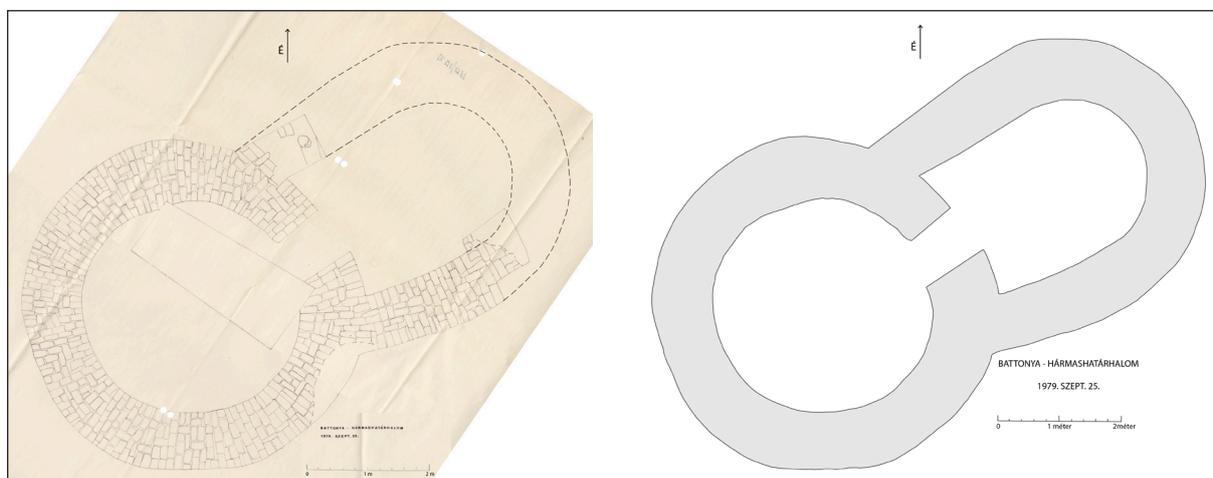
Fig. 28–29. Third possible shape of the Battonya round church sanctuary with semicircular closure (drawing: György Kerekes, 2025).

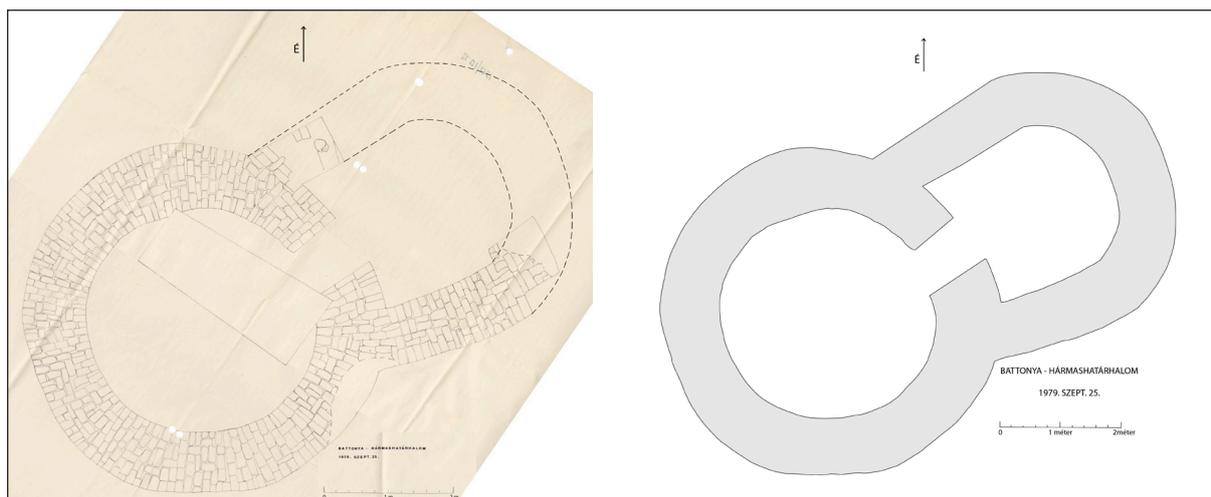
Fig. 30–31. The third possible shape of the Battonya round church sanctuary with a slightly sunken semicircular closure (drawing: György Kerekes, 2025).
